# Harlem Park

## *Manhattan, New York*

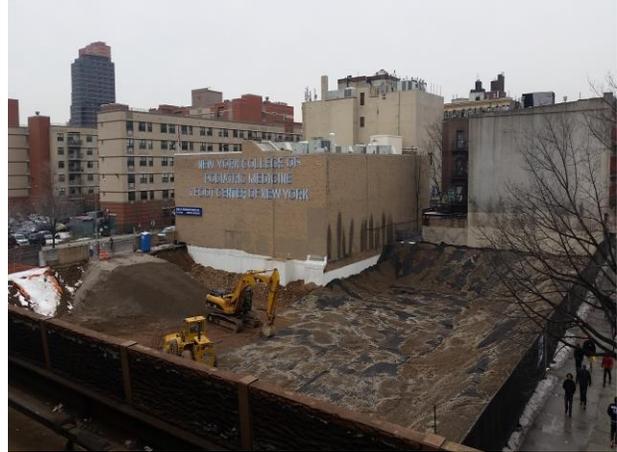
*View of the Site during excavation.*

As part of the Site remediation, FLS oversaw hot spot excavation of areas with soil contamination exceeding the Track 4 site-specific Soil Cleanup Objectives, implemented a Community Air Monitoring Plan, tracked soil disposal and handled procedures for underground tank disposal. In addition to hot spot remedial excavation to 13 fbg, the entire Site was excavated to 13 fbg for development purposes. Due to residual contamination left on Site, engineering and institutional controls consisting of a composite cover and an environmental easement were placed on the property. Currently the site is cover with a temporary 2ft. Recycled Concrete Aggregate cover. Remediation was completed in 2015 and the Certificate of Completion was obtained in 2016 qualifying the site owner for BCP tax credits.

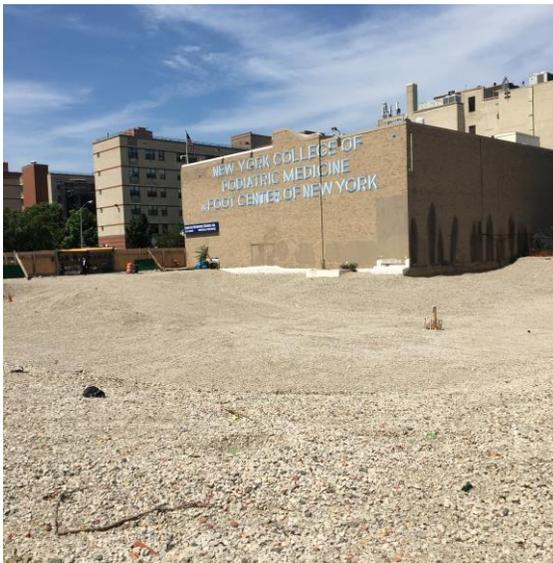
*View of the 2-foot Recycled Concrete Aggregate cover.*
